# Thermal Imaging Report

## Victorian Education Colleges

## Melbourne State College

# 30. DB-A2L Level 1 Lighting

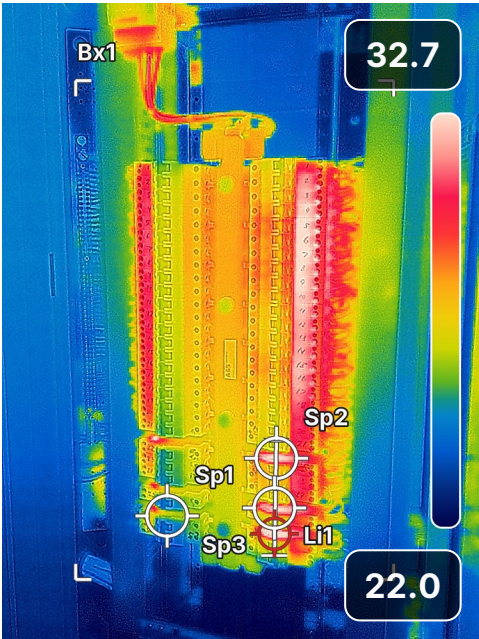
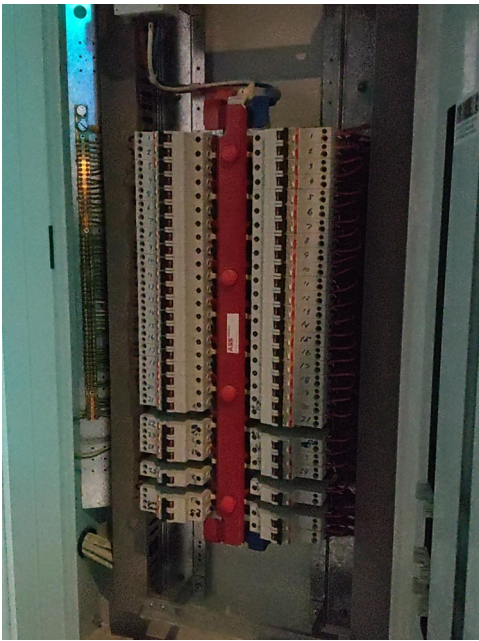
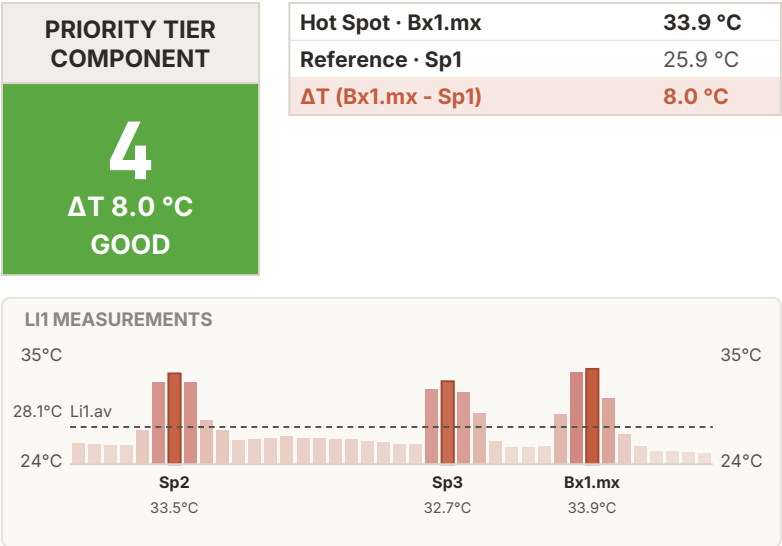
The terminal on the lower right breaker is warmer than the same point on the breaker beside it, though the reading itself is only warm. The heat sits right on that one connection and doesn't carry along the row.

No repair required.
